## Unscheduled Oil & Gas Repair

**SIFCO Applied Surface Concepts (ASC), worked together with the world leader in oilfield products and services, National Oilwell Varco (NOV) to repair critical damage caused by lightning strike on the Ensco 8505 drilling rig in the Gulf of Mexico within 24 hours of arrival on site, preventing costly unplanned downtime.**

Repair to critical drilling component after a lightning strike

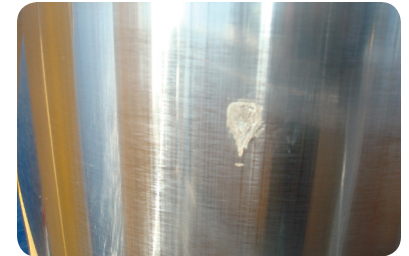
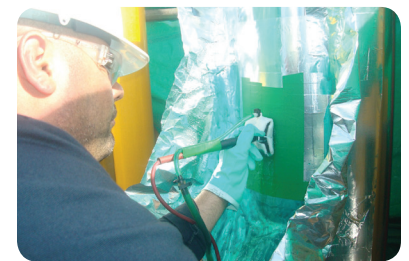
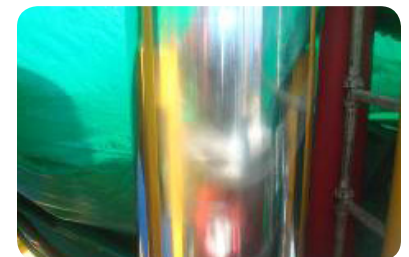
Significant damage was caused to the crown mounted compensator (CMC) cylinder when lightning struck the rig. The CMC is a device used to apply a constant tension to the drill string and compensate for any rig movement. The impact of the lightning strike caused a substantial gouge, the size of a coin, on the CMC cylinder. Without immediate repairs the damage would cause the cylinder seals to leak, resulting in hydraulic fluid loss and the threat of significant lost production.

The solution was found in SIFCO ASC's plating process, using SIFCO's AeroNikl® 7280 for corrosion protection, and Cobalt 2043 to cap the repair for hardness to protect against surface wear. The SIFCO Process® is unique to the company and involves a portable method of electroplating localised areas without the use of an immersion tank. The SIFCO Process® is highly regarded in the oil and gas industry and used on many OEM and repair applications, particularly as components can be plated in-situ and on-site, which ultimately saves time in maintenance, repairs and unplanned downtime.

When undertaking the repair work, two SIFCO ASC technicians were situated near the top of the derrick, 450ft in the air, to perform the repair. It took them a total of 24 hours to complete the work and return the platform to full operation, as opposed to three months to replace the shaft.

The final result was extremely successful. The repaired cylinder was dimensionally accurate to .001" tolerance as compared to the .005" tolerance originally requested by NOV.
